**Flood Control Project Maintenance
Levee Inspections****LMA District Cover Sheet****Spring 2016 Levee Inspection Results****Tehama County Flood Control and Water Conservation District**

**Flood Control Project Maintenance
Levee Inspections**

Spring 2016 Levee Inspection Results

Tehama County Flood Control and Water Conservation District

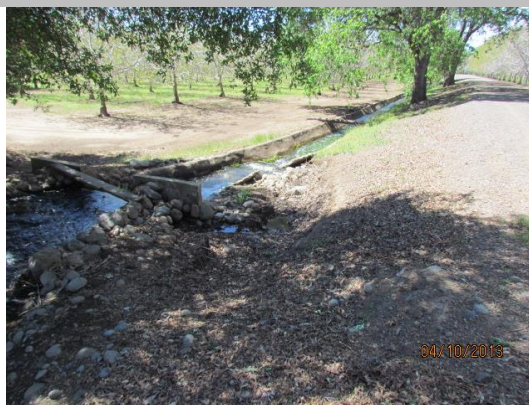
Photo 1 of 1 : SP_2016_NA0019_78_17_20160316_00009.jpg

View of the erosion along the landside slope.

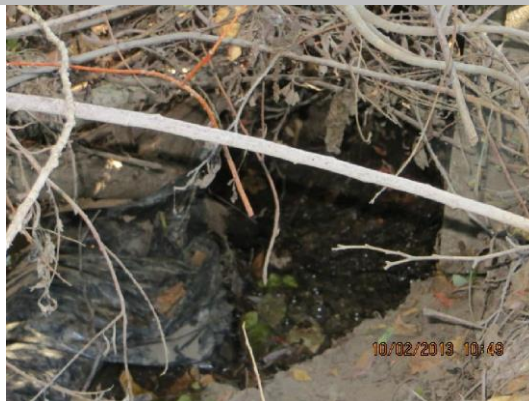
Photo 2 of 2 : UCIP_SP_2016_39840_39059.jpg

Pipe visible at WS outlet.

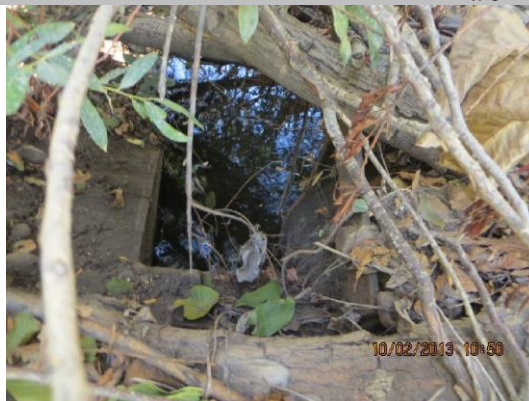
Photo 1 of 1 : UCIP_SP_2016_39838_39058.jpg

LM Start	0.17	Rating **	M	Issue No.	290
LM End	0.17	Issue Type +	En	Location *	WS
Category	Supplemental			GPS Latitude/Longitude	
				Start	End
Item	DWR UCIP Field Study			39.973285 °	39.973285 °
				-121.983531 °	-121.983531 °
DWR ID					
Comment Code					
Inspector Comment					
FS_ID:39838 DS_ID:24685 EP_NO: N/A Repair Type: Non-Urgent Crossing Status: Found UCIP Comments: No permit identified for this crossing. FIELD_STRUCT_DESC: 24-inch concrete irrigation pipe through the levee 2-feet below the crown. Concrete canal and distribution struture on LS shoulder. Concrete U-shaped headwall and flapgate on WS toe. FS Date: 10/2/2013

Concrete U-shaped headwall and flapgate at WS toe.

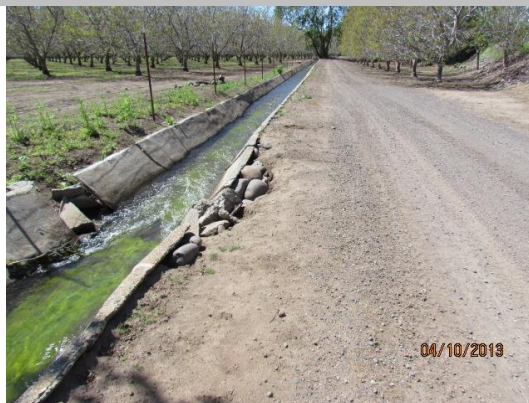
Photo 1 of 1 : SP_2016_NA0019_78_18_20160316_00010.jpg

LM Start	0.41	Rating **	M	Issue No.	18
LM End	0.41	Issue Type +	Ma	Location *	LS
Category	Earthen Levee			GPS Latitude/Longitude	
				Start	End
Item	Erosion / Bank Caving			39.972560 °	39.972560 °
				-121.987759 °	-121.987759 °
DWR ID	DWR_NA0019_01_s_2013_18				
Comment Code					
E1 : Note and monitor erosion site.					
Inspector Comment

View of the erosion along the landside slope.

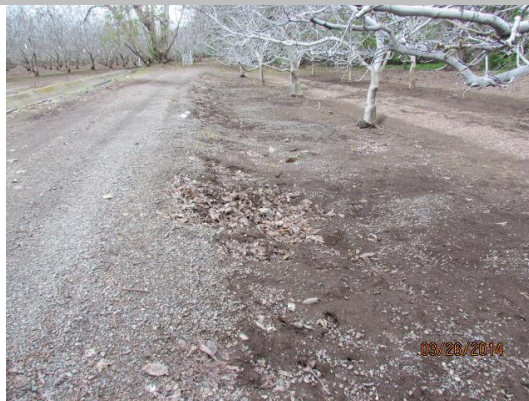
Photo 1 of 1 : SP_2016_NA0019_78_276_20160316_00018.jpg

LM Start	0.45	Rating **	M	Issue No.	276
LM End	0.45	Issue Type +	Ma	Location *	WS
Category	Earthen Levee			GPS Latitude/Longitude	
				Start	End
Item	Slope Stability			39.972377 °	39.972377 °
				-121.988559 °	-121.988559 °
DWR ID	DWR_NA0019_01_s _ 2014_276				
Comment Code					
S1 : Repair slope instability.					
Inspector Comment

View of the erosion along the waterside slope.

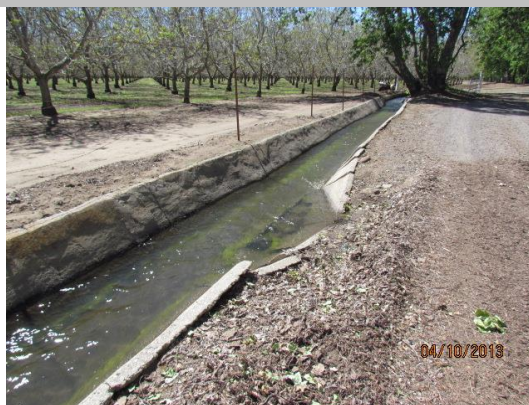
Photo 1 of 1 : SP_2016_NA0019_78_19_20160316_00011.jpg

LM Start	0.46	Rating **	M	Issue No.	19
LM End	0.46	Issue Type +	Ma	Location *	LS
Category	Earthen Levee			GPS Latitude/Longitude	
				Start	End
Item	Erosion / Bank Caving			39.972339 °	39.972339 °
				-121.988763 °	-121.988763 °
DWR ID	DWR_NA0019_01_s _ 2013_19				
Comment Code					
E1 : Note and monitor erosion site.					
Inspector Comment

View of the erosion along the landside slope.

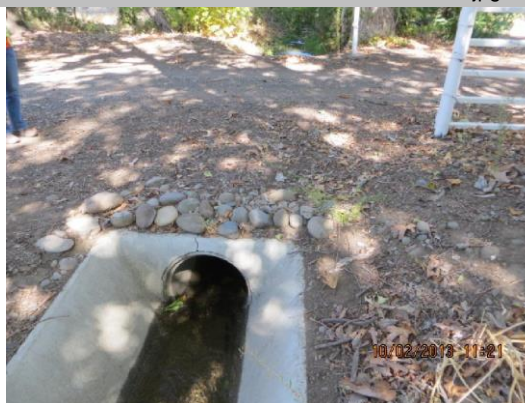
Photo 2 of 2 : UCIP_SP_2016_39839_39062.jpg

Concrete headwall at canal on LS shoulder.

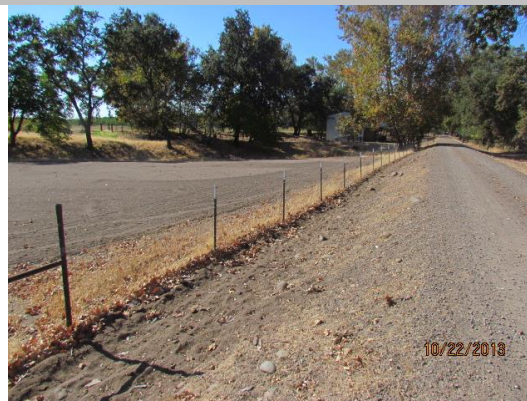
Photo 1 of 1 : SP_2016_NA0019_78_21_20160316_00013.jpg

LM Start	1.52	Rating **	M	Issue No.	21
LM End	1.52	Issue Type +	Ma	Location *	LS
Category	Earthen Levee			GPS Latitude/Longitude	
				Start	End
Item	Animal Control			39.969419 °	39.969419 °
				-122.007850 °	-122.007850 °
DWR ID	DWR_NA0019_01_f_2013_21				
Comment Code					
A2 : Repair the levee slope damaged by livestock and prevent large animal access.					
Inspector Comment

View of the erosion caused by livestock on both slope of the levee.

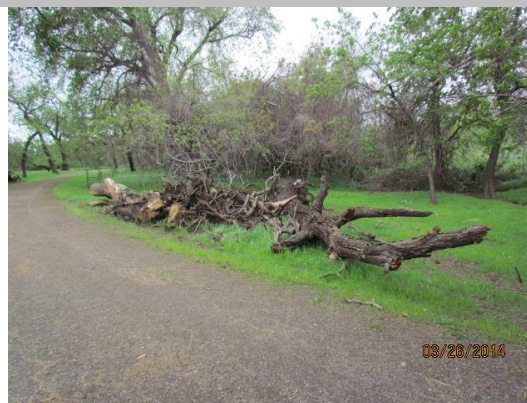
Photo 1 of 1 : SP_2016_NA0019_78_277_20160316_00019.jpg

LM Start	1.65	Rating **	M	Issue No.	277
LM End	1.65	Issue Type +	En	Location *	WS
Category	Earthen Levee			GPS Latitude/Longitude	
				Start	End
Item	Encroachments			39.968654 °	39.968654 °
				-122.010207 °	-122.010207 °
DWR ID	DWR_NA0019_01_s_2014_277				
Comment Code					
TR : Tree or limb					
Inspector Comment

View of the trees limbs along the waterside toe.

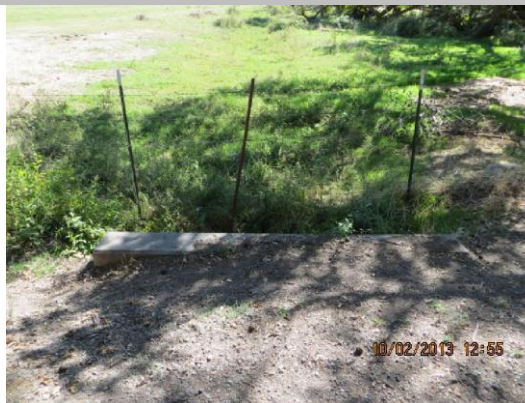
Photo 2 of 2 : UCIP_SP_2016_21729_36921.jpg

Concrete headwall on LS toe.

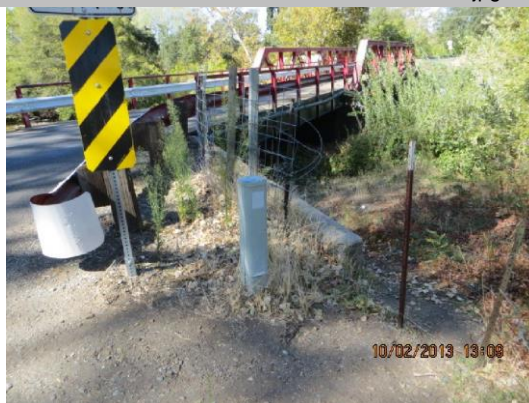
Photo 2 of 2 : UCIP_SP_2016_39837_39066.jpg

Communication box on WS shoulder.

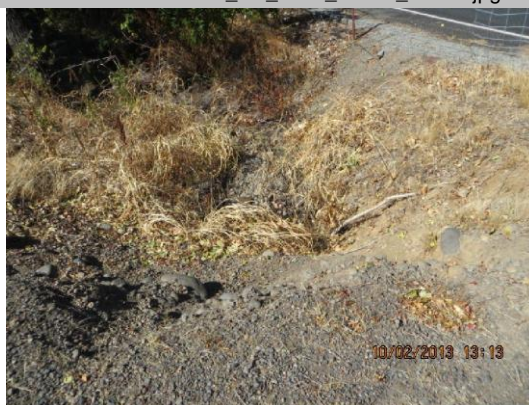
Photo 2 of 2 : UCIP_SP_2016_21730_36924.jpg

Outlet on WS toe.

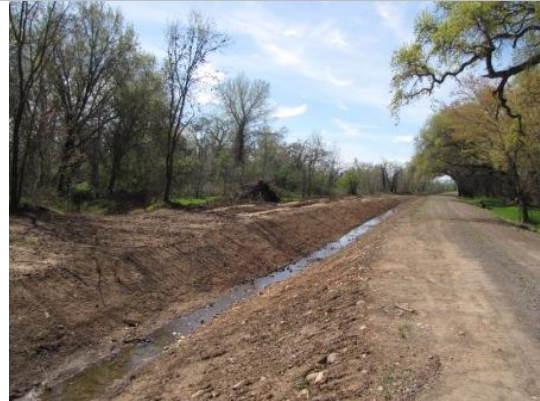
Photo 1 of 1 : SP_2016_NA0019_78_2_20160316_00001.jpg

Remove agricultural ditch from toe of levee.

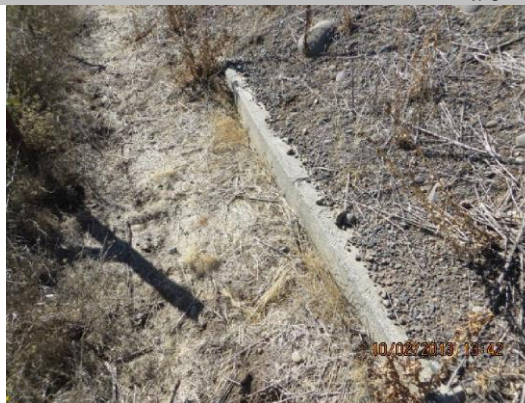
Photo 1 of 1 : UCIP_SP_2016_22823_38941.jpg

LM Start	2.57	Rating **	M	Issue No.	281
LM End	2.57	Issue Type +	En	Location *	CR
Category	Supplemental			GPS Latitude/Longitude	
				Start	End
Item	DWR UCIP Field Study			39.966363 °	39.966363 °
				-122.025755 °	-122.025755 °
DWR ID					
Comment Code					
Inspector Comment					
FS_ID:22823					
DS_ID:20877					
EP_NO: N/A					
Repair Type: Non-Urgent					
Crossing Status: Found					
UCIP Comments: Headwall covered with soil. Needs to be cleared at both ends.					
FIELD_STRUCT_DESC: 24-inch Corrugated mtl pipe through the levee 5-feet below the crown. Calco automatic drainage gate.					
Originally included in O+M manual (1957). As-built drawings available 50-4-2394.					
FS Date: 10/2/2013

Concrete headwall on LS toe.

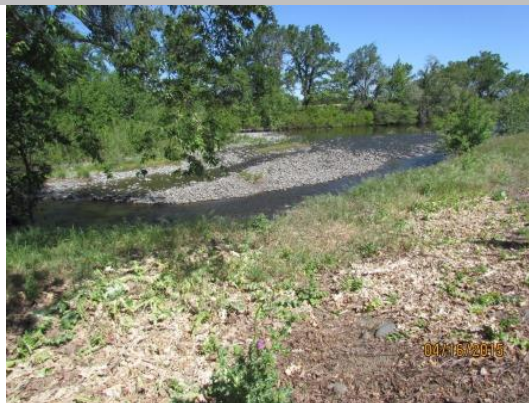
Photo 1 of 1 : SP_2016_NA0019_78_39_20160316_00016.jpg

View of the erosion along the waterside toe.

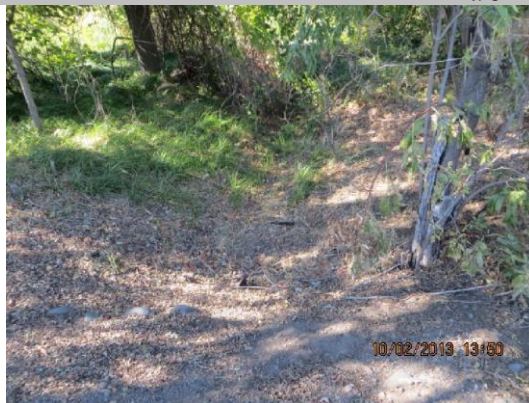
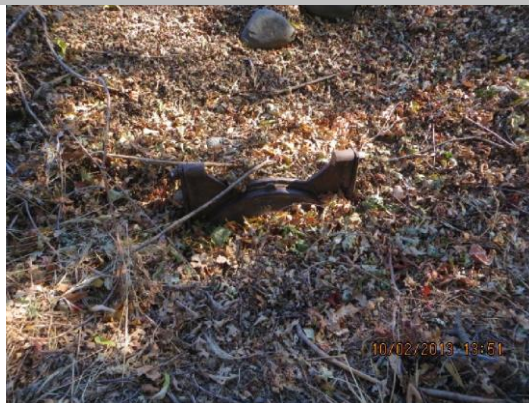
Photo 1 of 2 : UCIP_SP_2016_22824_38946.jpg

LM Start	2.86	Rating **	M	Issue No.	282
LM End	2.86	Issue Type +	En	Location *	CR
Category	Supplemental			GPS Latitude/Longitude	
				Start	End
Item	DWR UCIP Field Study			39.963938 °	39.963938 °
				-122.030128 °	-122.030128 °
DWR ID					
Comment Code					
Inspector Comment					
FS_ID:22824 DS_ID:20767 EP_NO: N/A Repair Type: Non-Urgent Crossing Status: Found UCIP Comments: Pipe blocked by soil. FIELD_STRUCT_DESC: 24-inch pipe through the levee 6-feet below the crown. Flap gate on the waterward end. Originally included in O+M manual (1957). As-built drawings available 50-4-2394. FS Date: 10/2/2013

Flapgate blocked by soil and debris.

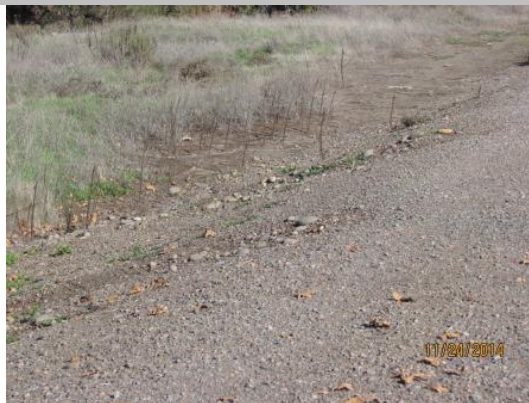
Photo 1 of 1 : SP_2016_NA0019_78_38_20160316_00015.jpg

LM Start	2.86	Rating **	M	Issue No.	38
LM End	2.86	Issue Type +	Ma	Location *	LS
Category	Earthen Levee			GPS Latitude/Longitude	
				Start	End
Item	Slope Stability			39.963928 °	39.963928 °
				-122.030120 °	-122.030120 °
DWR ID	DWR_NA0019_01_f_2014_38				
Comment Code					
S1 : Repair slope instability.					
Inspector Comment

View of erosion from the cattle on both slopes.

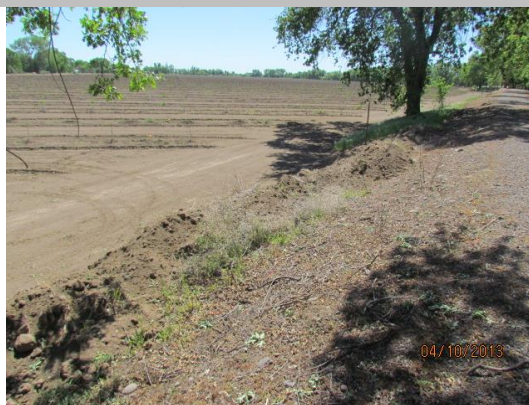
Photo 1 of 1 : SP_2016_NA0019_78_20_20160316_00012.jpg

LM Start	2.88	Rating **	M	Issue No.	20
LM End	2.88	Issue Type +	Ma	Location *	LS
Category	Earthen Levee			GPS Latitude/Longitude	
				Start	End
Item	Slope Stability			39.963709 °	39.963709 °
				-122.030384 °	-122.030384 °
DWR ID	DWR_NA0019_01_s_2013_20				
Comment Code					
S1 : Repair slope instability.					
Inspector Comment

View of the erosion along the landside slope.

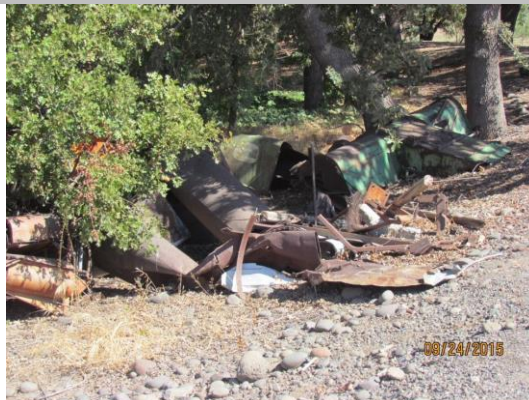
Photo 1 of 1 : SP_2016_NA0019_78_37_20160316_00014.jpg

View of the scrap equipment along the waterside toe.

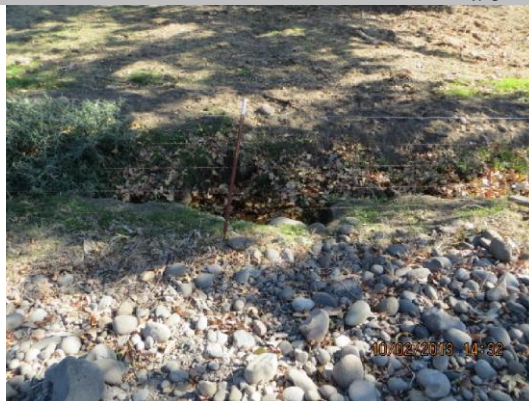
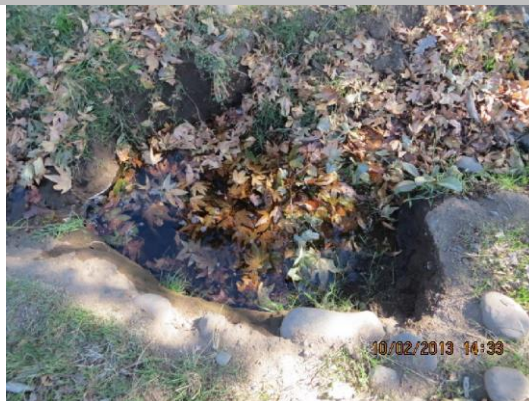
Photo 1 of 2 : UCIP_SP_2016_22825_38952.jpg

LM Start	3.29	Rating **	M	Issue No.	283
LM End	3.29	Issue Type +	En	Location *	WS
Category	Supplemental			GPS Latitude/Longitude	
				Start	End
Item	DWR UCIP Field Study			39.947484 °	39.947484 °
				-122.049011 °	-122.049011 °
DWR ID					
Comment Code					
Inspector Comment					
FS_ID:22825					
DS_ID:20766					
EP_NO: N/A					
Repair Type: Non-Urgent					
Crossing Status: Indicator Found					
UCIP Comments: Pipe buried. Water flows to low spot and dissapears, but pipe not visible.					
FIELD_STRUCT_DESC: 24-inch pipe through the levee 8-feet below the crown, flap gate on waterward end. Originally included in O+M manual (1957). As-built drawing No. 50-4-2394.					
FS Date: 10/2/2013

Low spot with water on LS toe.

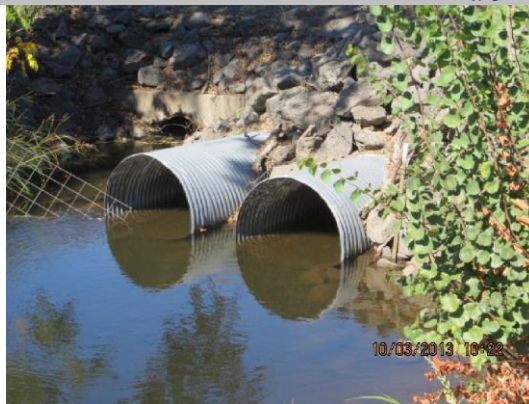
Photo 2 of 2 : UCIP_SP_2016_23007_39069.jpg

Pipe visible on LS toe.

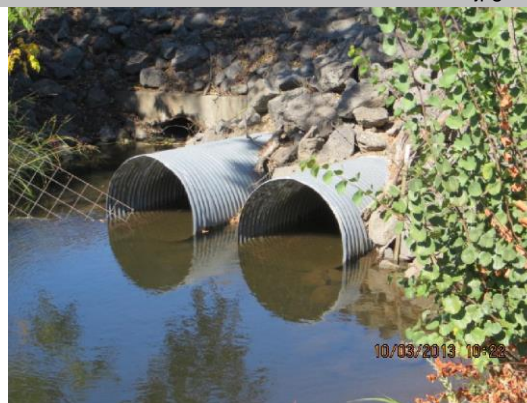
Photo 2 of 2 : UCIP_SP_2016_39836_39072.jpg

Pipe visible on LS toe.

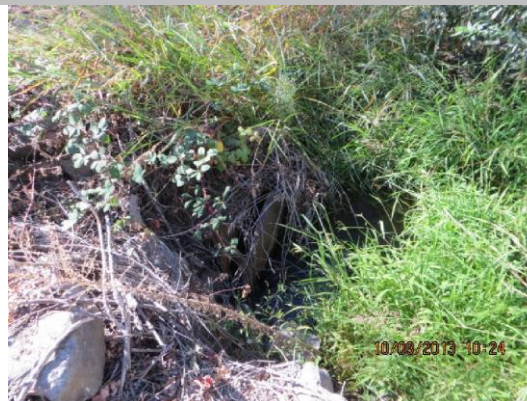
Photo 2 of 2 : UCIP_SP_2016_41126_39075.jpg

Flapgate visible on WS toe.

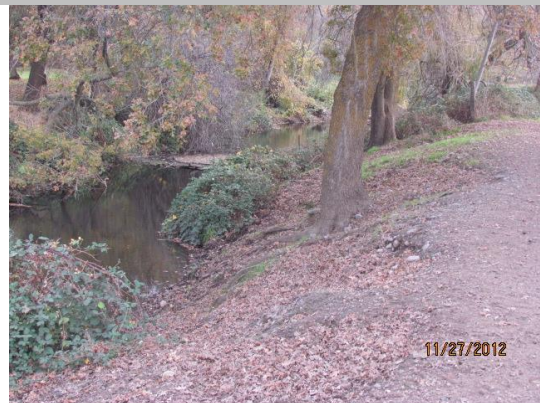
Photo 1 of 1 : SP_2016_NA0019_78_15_20160316_00007.jpg

View of the erosion caused by livestock along the landside slope.

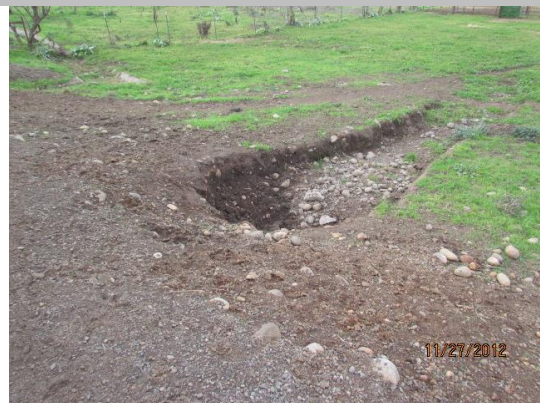
Photo 1 of 1 : SP_2016_NA0019_78_16_20160316_00008.jpg

View of the ditch along the waterside toe.

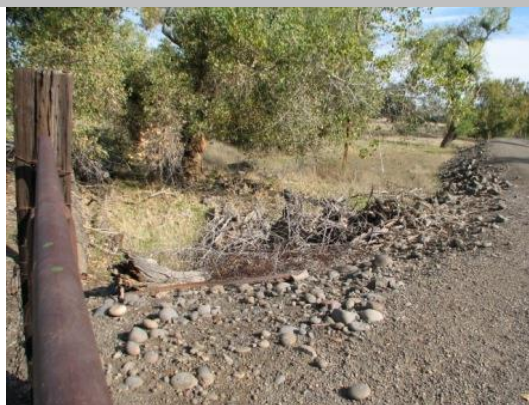
Photo 1 of 1 : SP_2016_NA0019_79_2_20160316_00001.jpg

View of debris & wire at toe of levee.

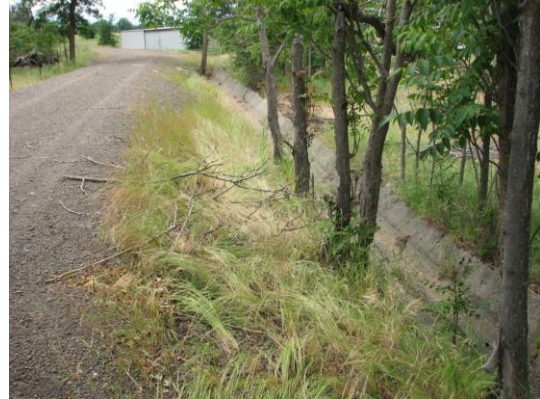
Photo 1 of 1 : SP_2016_NA0019_79_11_20160506_00012.jpg

04/26/2016: Concrete-lined ditch at L/S toe.

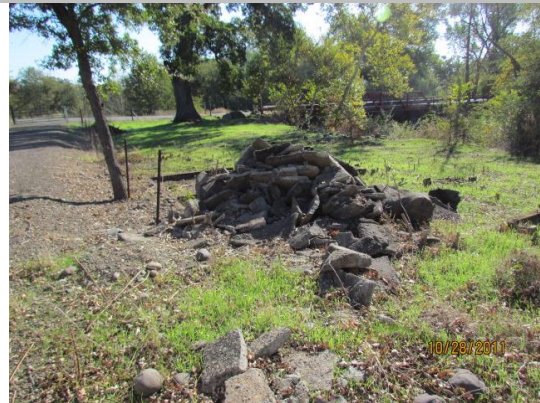
Photo 1 of 1 : SP_2016_NA0019_79_4_20160316_00003.jpg

View of the concrete pile along the W/S toe.

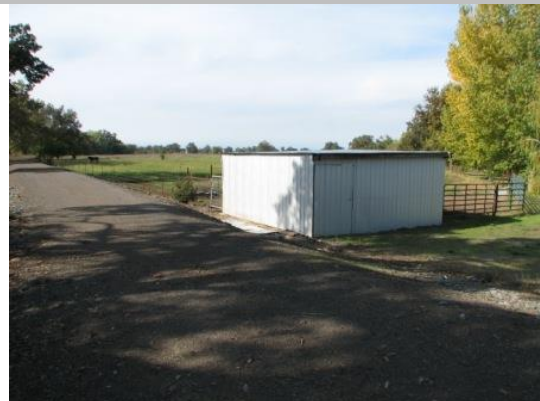
Photo 1 of 1 : SP_2016_NA0019_79_7_20160316_00005.jpg

View of building at toe of levee.

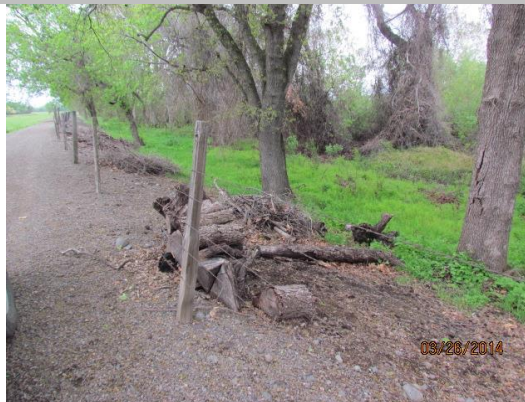
Photo 1 of 1 : SP_2016_NA0019_79_6_20160316_00004.jpg

Remove all firewood from the waterside slope.

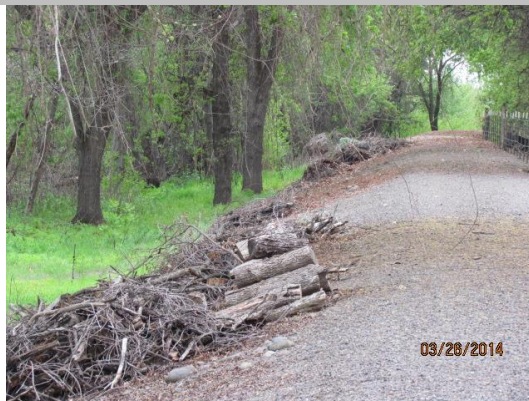
Photo 1 of 1 : SP_2016_NA0019_79_3_20160316_00002.jpg

View of the debris along the waterside slope.

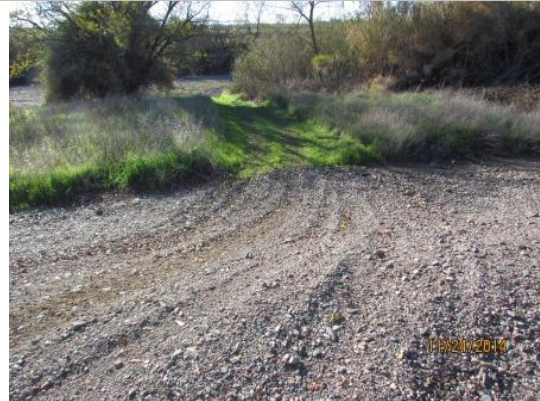
Photo 1 of 1 : SP_2016_NA0019_81_16_20160316_00011.jpg

View of the vehicle erosion along the waterside slope.

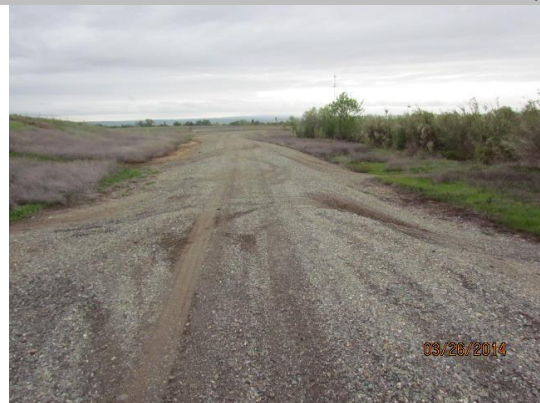
Photo 1 of 1 : SP_2016_NA0019_81_3_20160316_00003.jpg

View of the levee slope damaged by vehicle traffic.

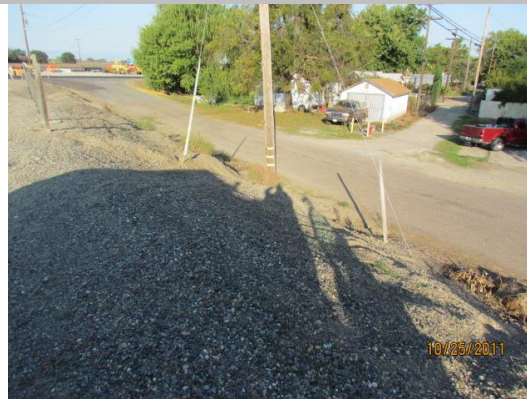
Photo 1 of 1 : SP_2016_NA0019_81_18_20160316_00013.jpg

View of the vehicle erosion along the L/S slope.

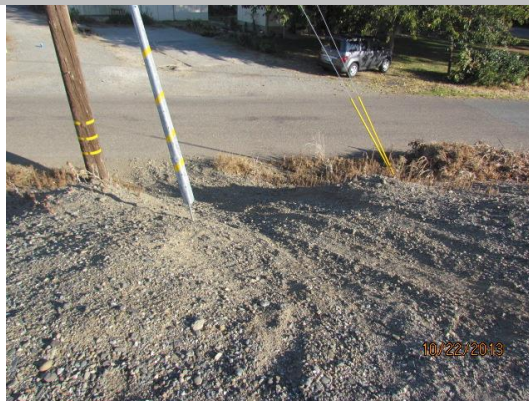
Photo 1 of 1 : SP_2016_NA0019_81_12_20160316_00007.jpg

View of the vehicle erosion along the landside slope.

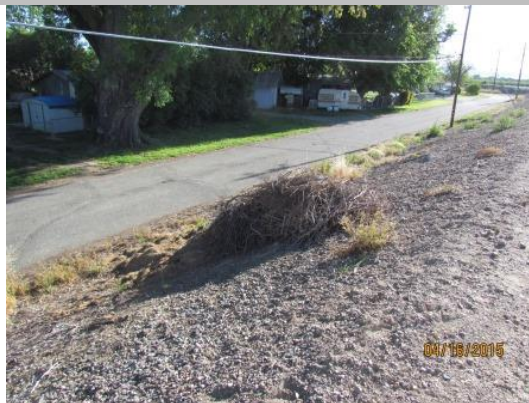
Photo 1 of 1 : SP_2016_NA0019_81_14_20160316_00008.jpg

View of the prunings along the landside slope.

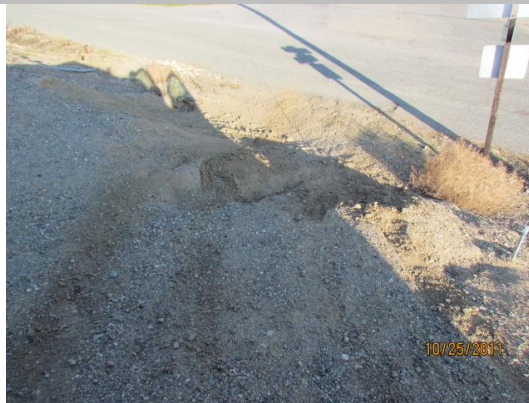
Photo 1 of 1 : SP_2016_NA0019_81_20_20160316_00015.jpg

View of the vehicle erosion along the L/S slope.

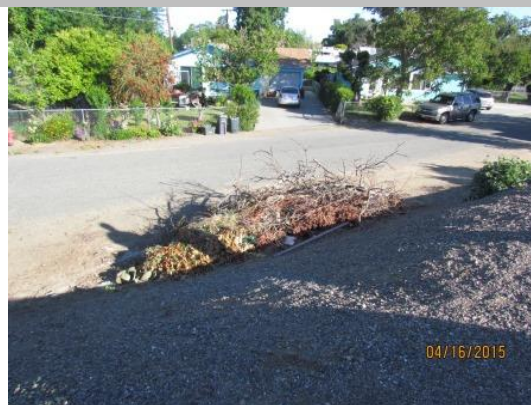
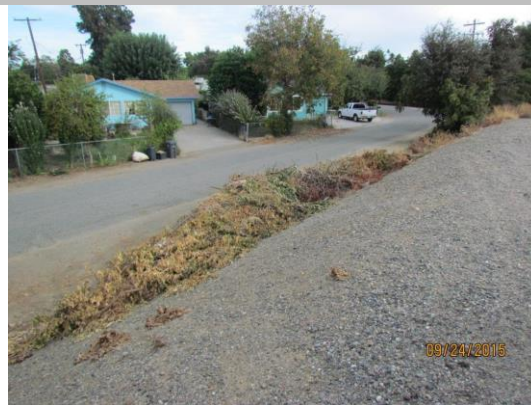
Photo 1 of 2 : SP_2016_NA0019_81_15_20160316_00009.jpg

View of the prunings along the landside toe.

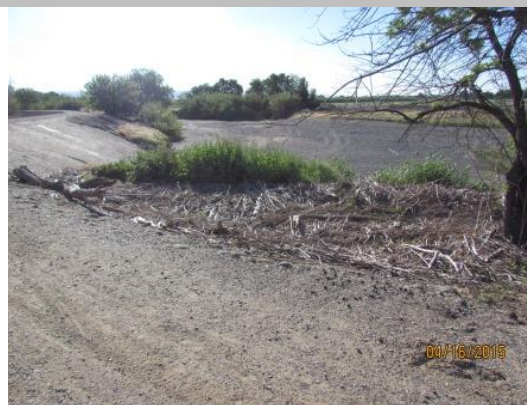
Photo 1 of 1 : SP_2016_NA0019_81_19_20160316_00014.jpg

View of the debris along the waterside slope.

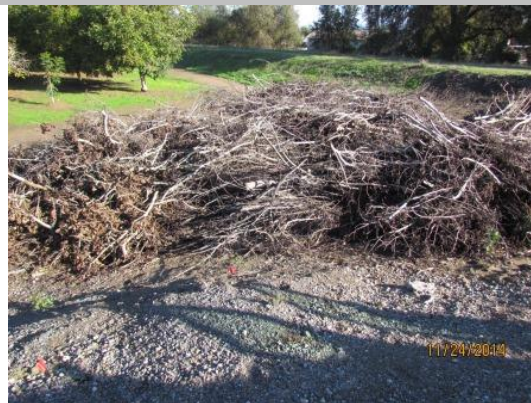
Photo 1 of 1 : SP_2016_NA0019_81_17_20160316_00012.jpg

View of the prunings along the landside slope.

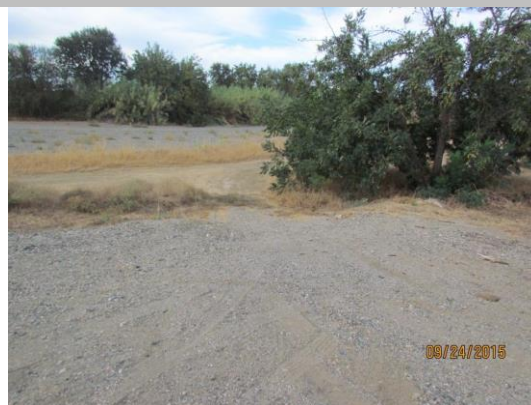
Photo 1 of 1 : SP_2016_NA0019_81_10_20160316_00005.jpg

View of the vehicle erosion along the waterside slope.

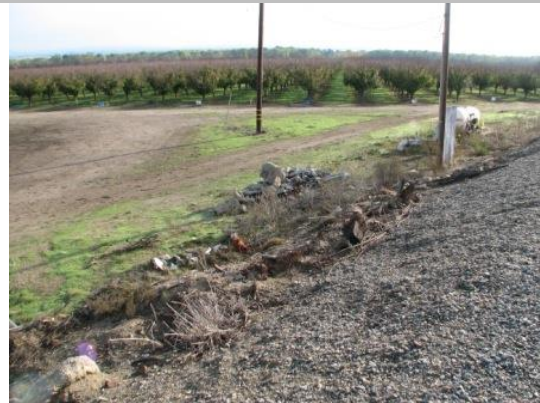
Photo 1 of 1 : SP_2016_NA0019_81_6_20160316_00004.jpg

View of the garbage and metal along the landside slope and toe of the levee.

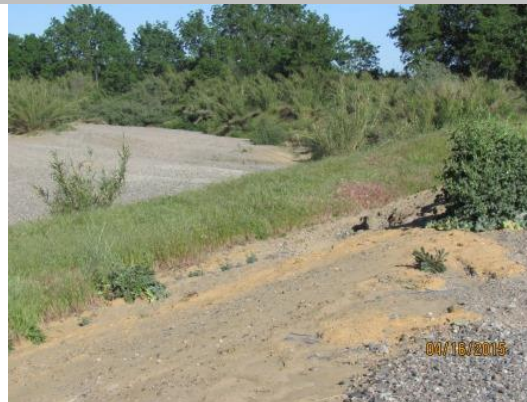
Photo 1 of 1 : SP_2016_NA0019_81_23_20160316_00018.jpg

View of the erosion along the waterside slope.

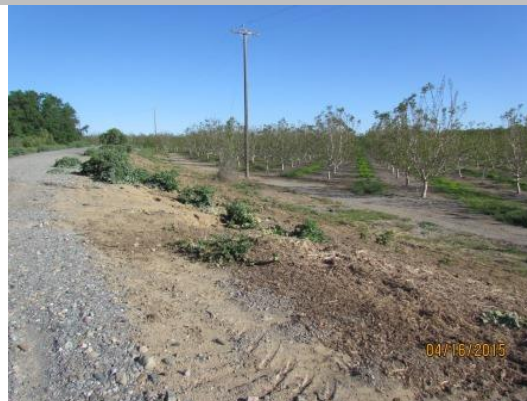
Photo 1 of 1 : SP_2016_NA0019_81_22_20160316_00017.jpg

View of the erosion along the landside slope.

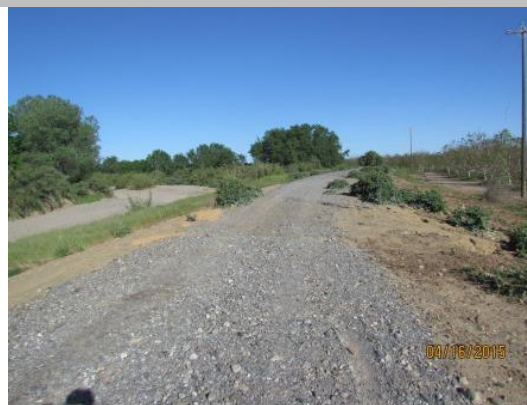
Photo 1 of 1 : SP_2016_NA0019_81_24_20160316_00019.jpg

View of the erosion on the crown roadway.

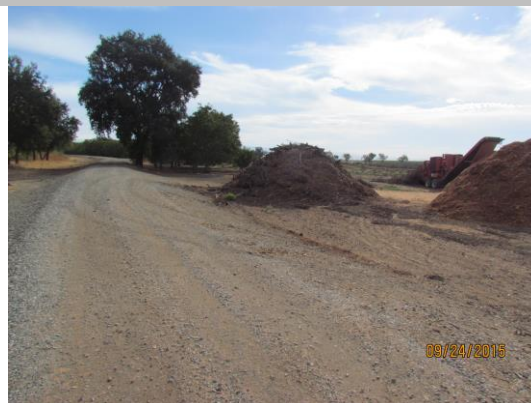
Photo 2 of 2 : SP_2016_NA0019_82_16_20160316_00007.jpg

View of the Chip prunings along the landside toe.

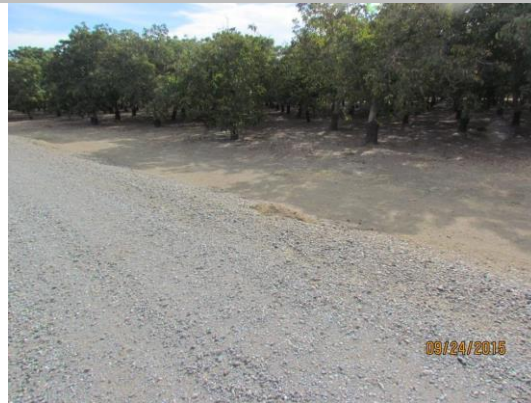
Photo 1 of 1 : SP_2016_NA0019_82_8_20160316_00003.jpg

View of the rodent holes along the landside slope.

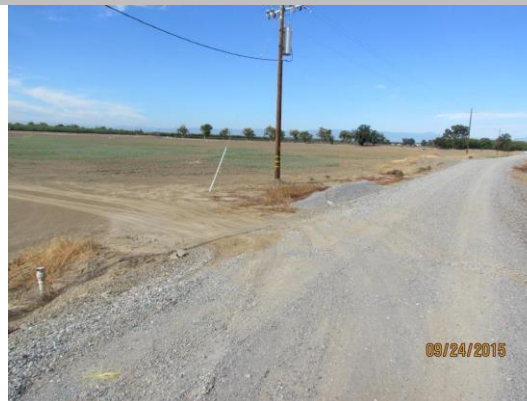
Photo 1 of 1 : SP_2016_NA0019_82_13_20160316_00004.jpg

View of the vehicle erosion along the landside slope.

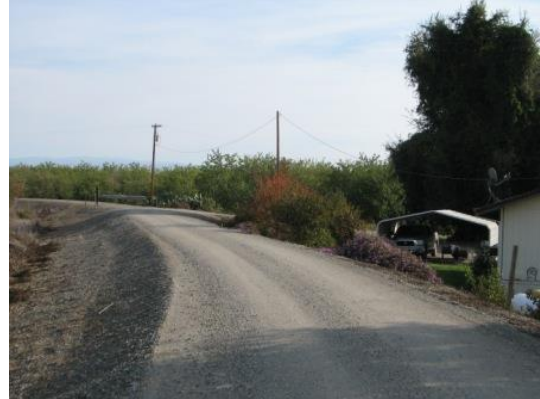
Photo 1 of 1 : SP_2016_NA0019_82_2_20160316_00001.jpg

View of the landscaping along the slope.

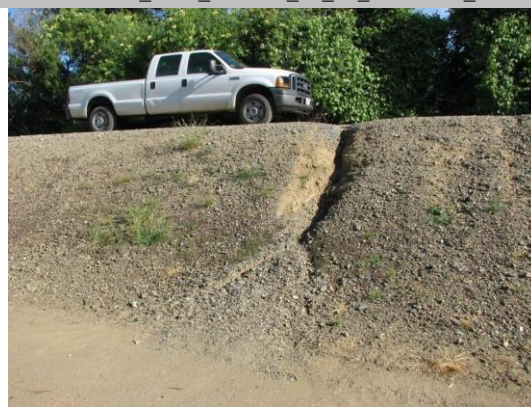
Photo 1 of 1 : SP_2016_NA0019_82_10_20160506_00016.jpg

04/26/2016: Erosional rutting on L/S slope.

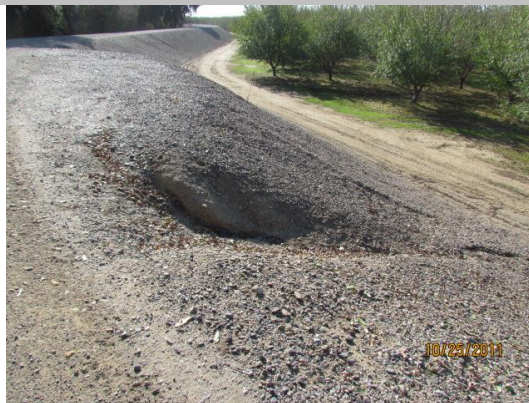
Photo 1 of 1 : SP_2016_NA0019_82_7_20160316_00002.jpg

View of the erosion along the L/S slope.
